## PRE-PURCHASE INSPECTION REPORT

# 2017 Smart ForFour Proxy

INSPECTION DATE  
**2026-07-20**

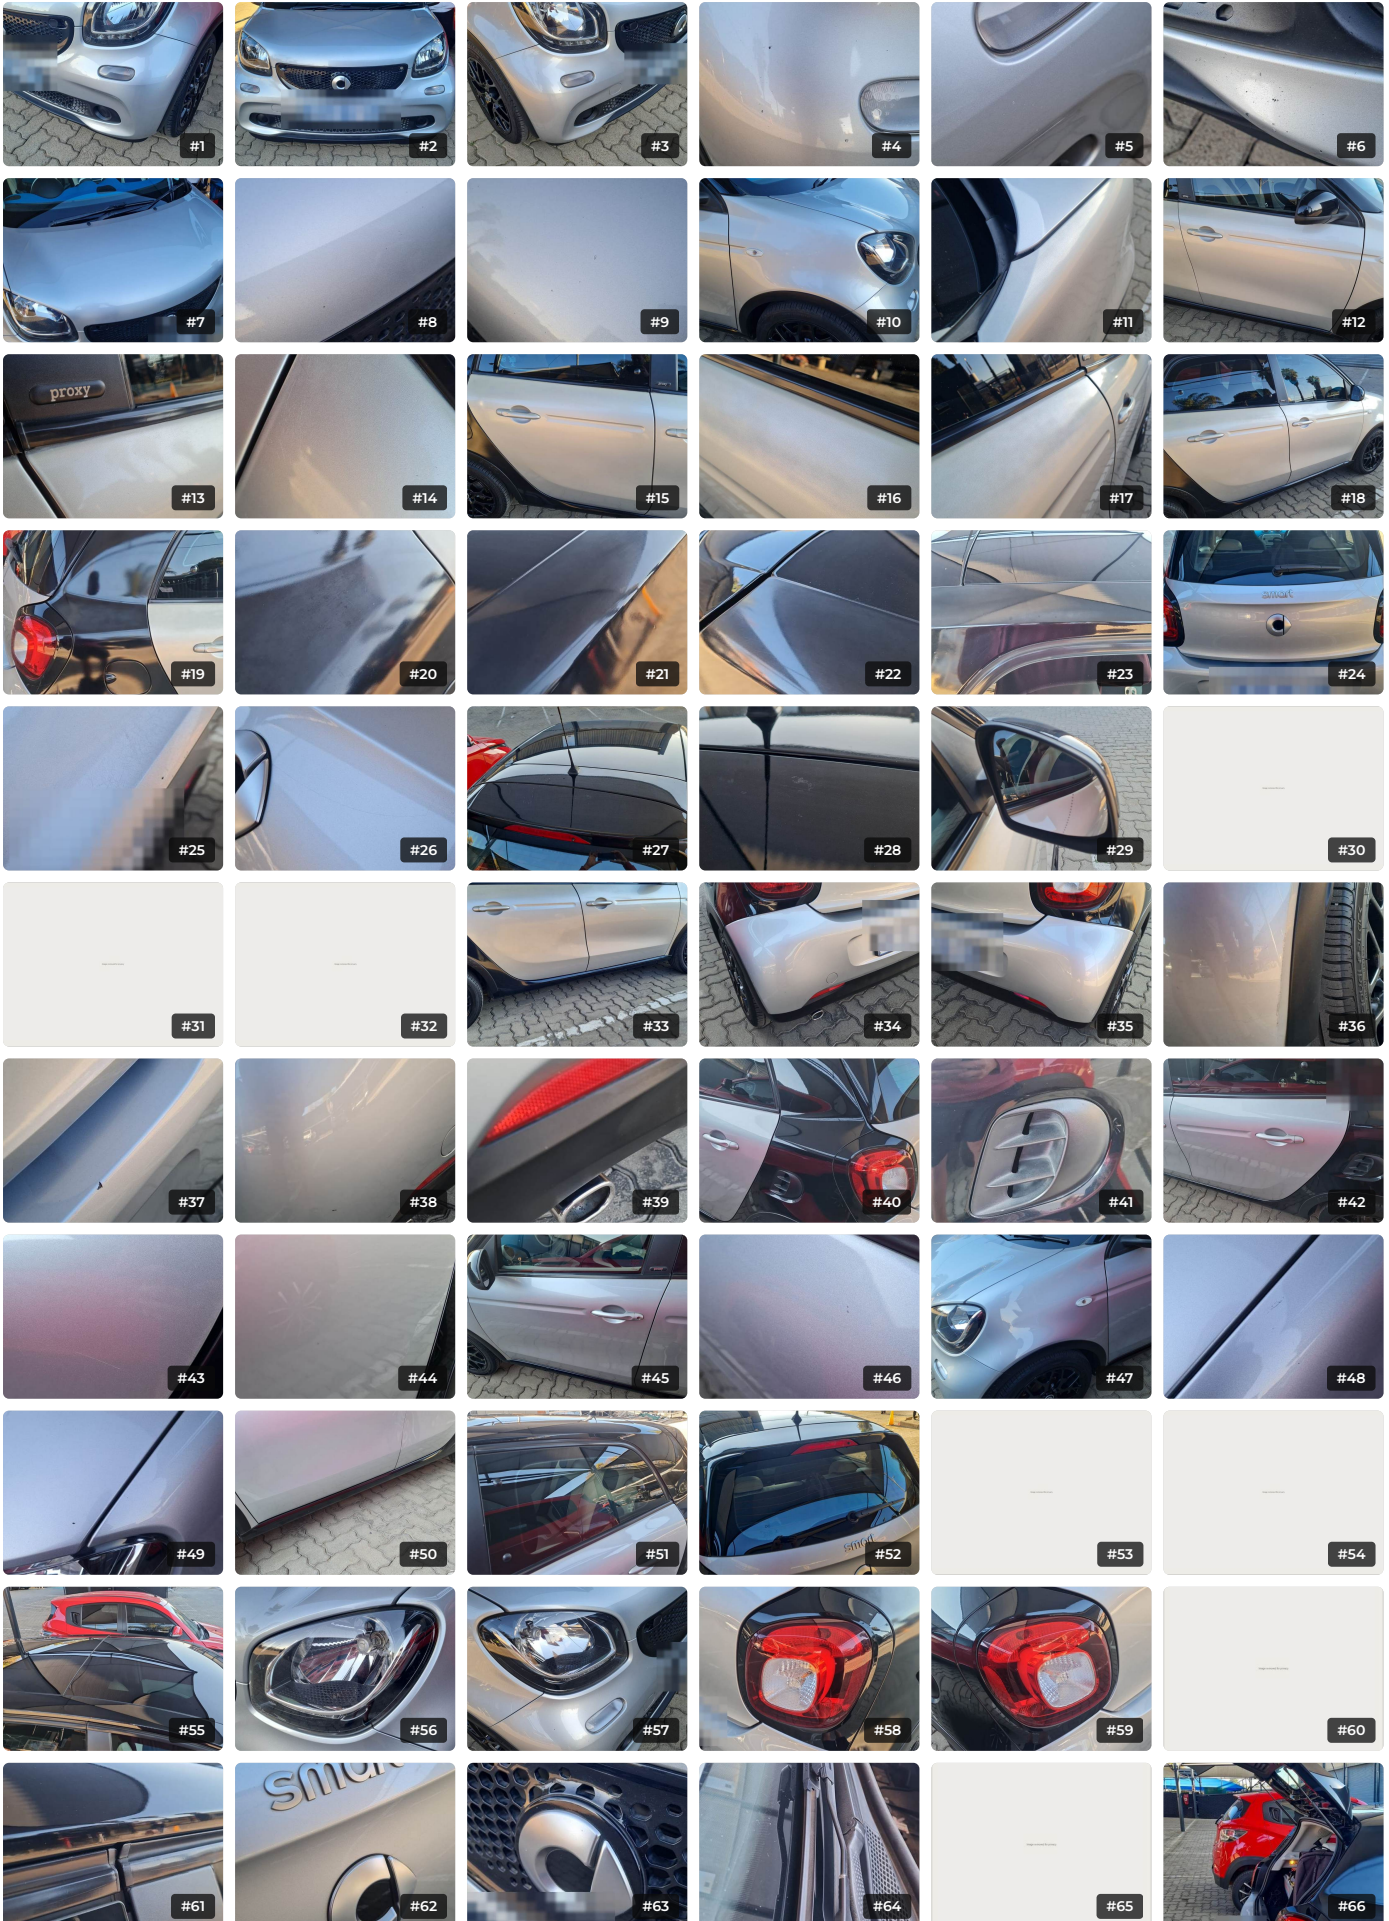
The vehicle is presented in metallic silver with a metallic black Tridion safety cell offset and is fitted with the Urban package, which adds black arch details. The arches and associated trim are in good condition with no fading. The passenger side of the vehicle is in very good to excellent condition throughout. All paintwork is original from front to rear. The passenger front fender has minor scratching on the upper section that should polish out. The passenger front and rear doors are in good condition with only minor touchable chips. The passenger rear quarter panel and plastic air intake are in excellent condition. The passenger side sill carries original paint all the way through. The driver's side is a significant concern. All paintwork from the front door rearward is non-original and of poor quality. The driver's rear door is the worst panel on the car — clear coat has fully failed on the upper sections, peeling through to base coat and presenting as hazy and smoky. The driver's rear quarter panel shows the same failure, with a visible blend line running to approximately halfway toward the front door and fish eyes and dulling throughout. The driver's front fender and driver's door have also been resprayed; clear coat is hazing and cracking on both. The driver's side as a whole will require respraying within the next year. The driver's door weather stripping has been removed and not refitted correctly, sitting slightly elevated toward the rear of the door. The bonnet carries original paintwork with a fair amount of stone chipping and sandblasting consistent with age. The front bumper is original — lower sections and bumper guard plastics are in excellent condition — however the key insert cover on the grille is missing and will need to be sourced. The roof is original; the driver's side repaint does not extend onto it. The panoramic roof glass panels are in excellent condition. The boot lid is original with minor touchable chips and polishable scratching at the closing point. The windscreen is the original Smart Pilkington unit with SRS logos intact and no evidence of replacement. Minor sandblasting is present, consistent with age — no chips or cracks. All remaining glass is in excellent condition. The vehicle is fitted with a legal smash-and-grab anti-hijack tint; rear sections are significantly darker than the front and the tint is in good condition. Headlights are original and match the wear of the bonnet and front bumper. The vehicle does not feature front fog lights; the plastic trim housing is in reasonable condition but could benefit from a clean. Side indicators are in excellent condition. Both rear taillights are original, matching in age and wear, and in good to excellent condition. Side mirrors show minor stone chipping and sandblasting consistent with the front of the vehicle; mirror glass is in fantastic condition. Front wipers are universal Bosch units in reasonable condition — replacement is advised within the next six to eight months. The rear wiper has a damaged metal support bracket and requires immediate replacement for roadworthy purposes. The exhaust tip is in good condition — shiny and presentable. Arch liners front and rear are in great condition with all clips, screws, and trim pieces present and original.

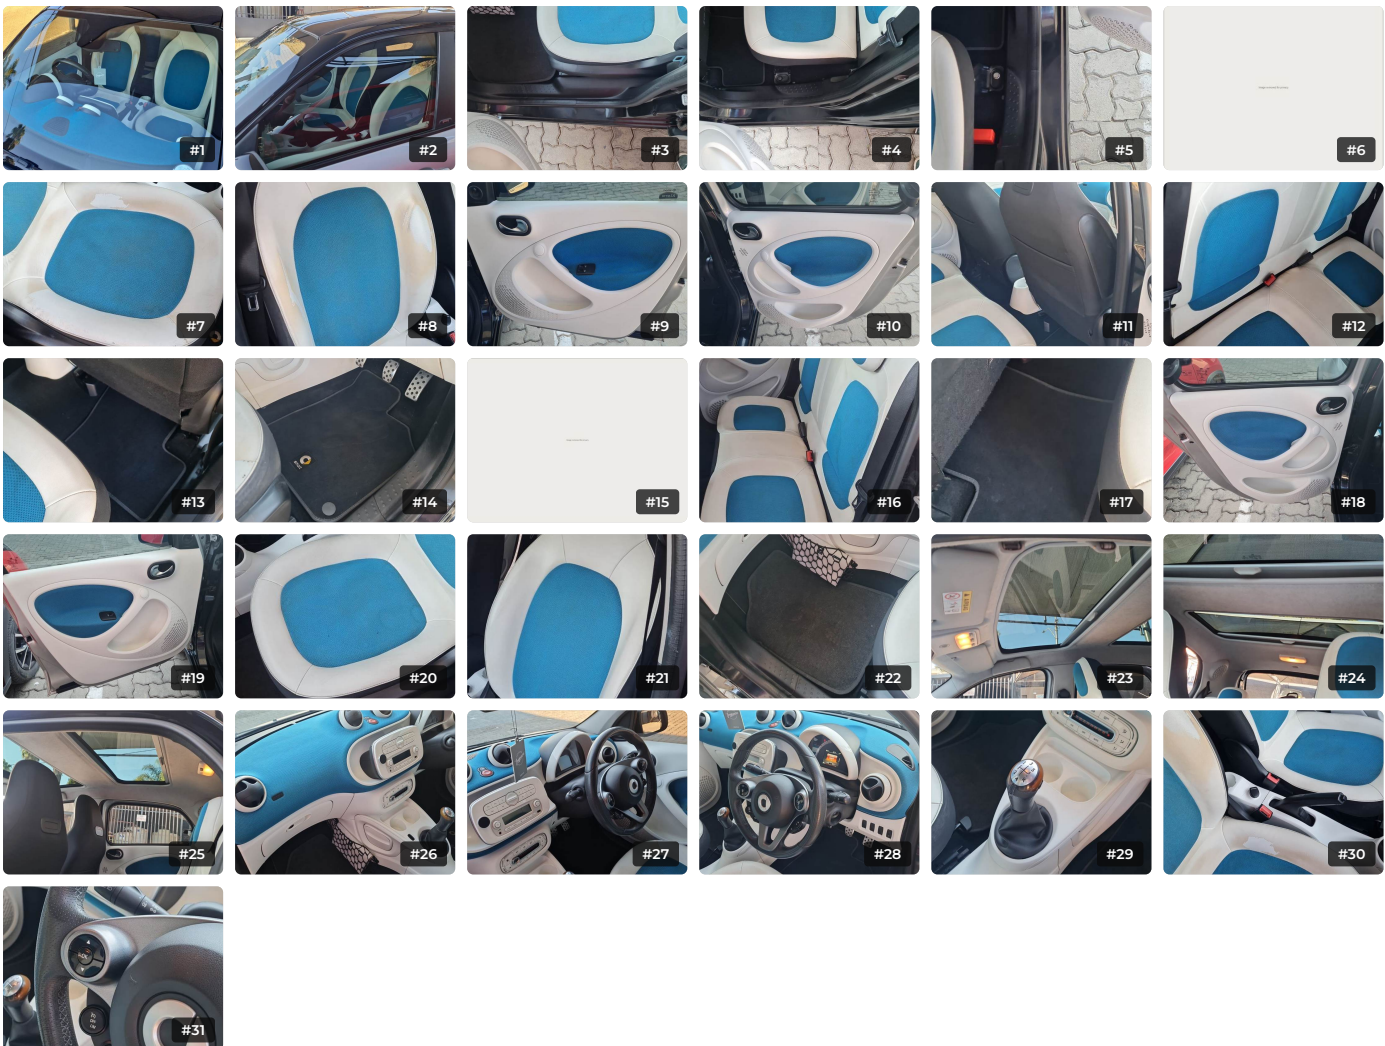
The interior is finished in the Proxy model's distinctive blue and white colour scheme — stark white with a sensitive baby blue that is known not to age particularly well. Overall the interior presents as well-maintained in most areas, with the driver's seat being the notable exception. The driver's seat is the worst element of the entire interior. The leather vinyl has delaminated and caused the seat to go brown — a known issue on these vehicles. Reupholstery is the only remedy. The seat is not torn or otherwise damaged beyond this atypical wear. The passenger seat, by contrast, is in significantly better condition, consistent with very little use; it has one or two minor fabric snags or small burn marks, likely from clothing contact, but is fundamentally sound. The rear bench is in considerably better condition than the front seats, consistent with the vehicle not having carried many passengers regularly. The blue fabric inserts and rear seat upholstery would benefit from a professional clean. The steering wheel is in good condition with a pleasing satin sheen — leather is undamaged and the perforations remain crisp. The gear lever knob leather has torn and exposed the plastic underneath; it will need to be replaced, though functionality is unaffected. The instrument cluster and dashboard are in exceptional condition. All dashboard trim, the centre console, air conditioning controls, radio, and surrounding trim are very clean. All airbags are present and intact. Door card plastic trim on all four doors is in exceptional condition. The blue fabric inserts across all four doors have minor dirt and staining and would benefit from a wet vacuum extraction clean — the rear driver's side insert has the most noticeable marks. Door rubbers, seals, and plastic trim are in great condition throughout the vehicle. The beige headliner is in fairly good condition with no sagging — a clean is recommended. Carpets are in good condition throughout. All mats are present; the front driver's mat is the original Smart unit. The front passenger mat is a non-original replacement that fits well but is a slightly different colour to the rest. Rear carpets and mats are in good condition. The boot interior is clean with good plastics. The factory boot netting is present and functional. The parcel shelf is missing. Boot rubbers and seals are in good condition. The vehicle is fitted with the Proxy and Brabus Sport Pack aluminium pedal covers, which are in good, clean condition. Driver's side interior sills have minor scratching on the metallic black glass sections; the plastic sections are presentable.

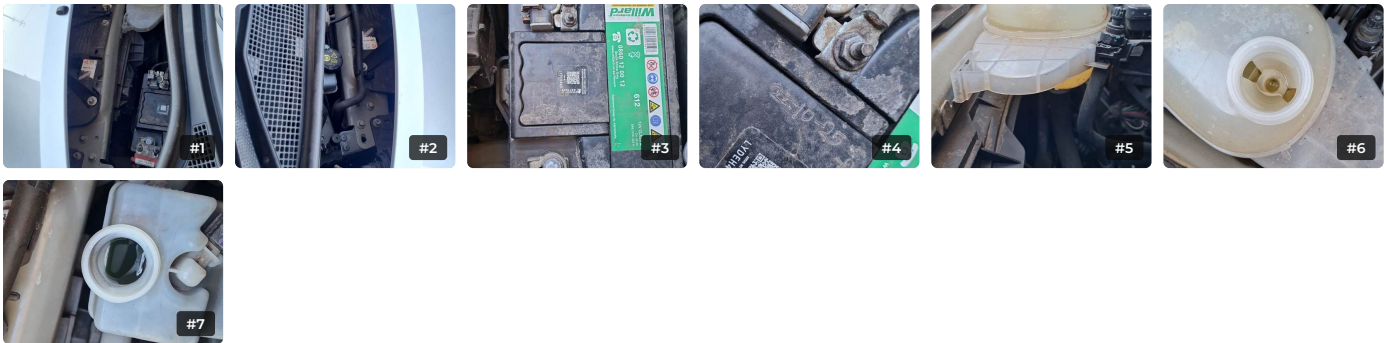
The engine bay on this Smart ForFour is rear-mounted and sealed, which limits direct visual inspection of several components. The seller, a qualified mechanic, verbally confirmed oil level and belt condition are satisfactory — these could not be independently verified. Oil cap shows notable sludge, which warrants monitoring. Coolant is over-diluted; a partial drain and top-up with concentrate will bring the mixture back to specification. Brake fluid is slightly dark and a fluid flush — brake and clutch — is recommended within the next few months as a precaution. The battery is a Willard 612 standard lead-acid unit fitted in October 2025. This vehicle requires an AGM battery due to its start-stop system; the mismatch is not an immediate failure risk but will reduce battery longevity over time. The bonnet operates via a sliding mechanism unique to this model — no shocks or conventional latch are fitted by design, and the mechanism functions correctly. Engine mount assessment was performed functionally: no play or abnormal vibration detected under torque load. One active DME fault code is present — P2234, an upstream oxygen sensor short circuit on Bank 1, Sensor 1. The engine warning light is illuminated. The vehicle is running open-loop on this sensor, resulting in a rich-running condition and elevated fuel consumption. Sensor replacement is recommended. The air conditioning compressor engages but delivers no cool air to the cabin — a regas is required at minimum. Windscreen washer bottle is in good condition.

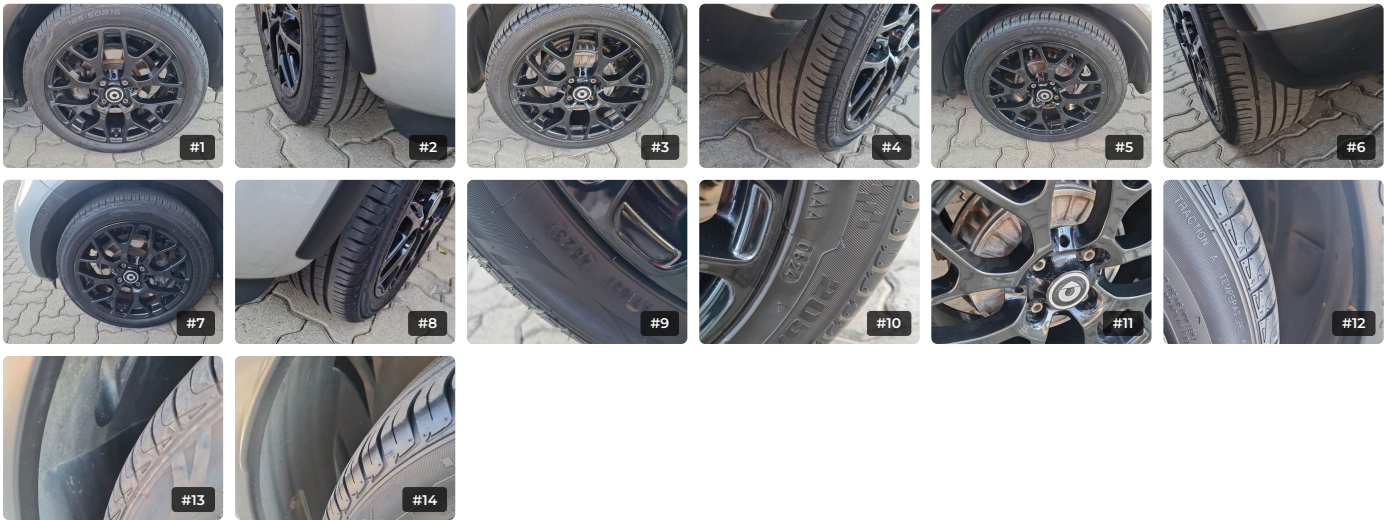
Three of the four tyres are in excellent condition. The front pair — 185/50 R16 Royal Black Royal Mile — present with healthy tread, no bubbles or deformities, and carry a 2023 DOT date stamp. The driver rear — 205/45 R16 Royal Black Royal Performance — is equally healthy with a 2024 DOT date stamp. The passenger rear shares the same specification and date but has a sidewall bubble: it is not roadworthy and requires immediate replacement. The inspector recommends replacing both rear tyres as a matched pair. All four wheels are gloss black. Three present as original and acceptable; the driver rear shows minor evidence of a previous refurbishment on the edges, consistent with pothole contact. All wheels could benefit from minor cosmetic touch-ups but none require full refurbishment. This vehicle does not use lock nuts — the four-hole PCD is universal to the Smart platform. All wheel nuts are present and accounted for.
